**HYDROGEOLOGICAL INVESTIGATION
OF
PEEBLES STREET LANDFILL SITE,
CALEDONIA**

OCTOBER 1989

Report prepared by:
M.M. Dillon Limited

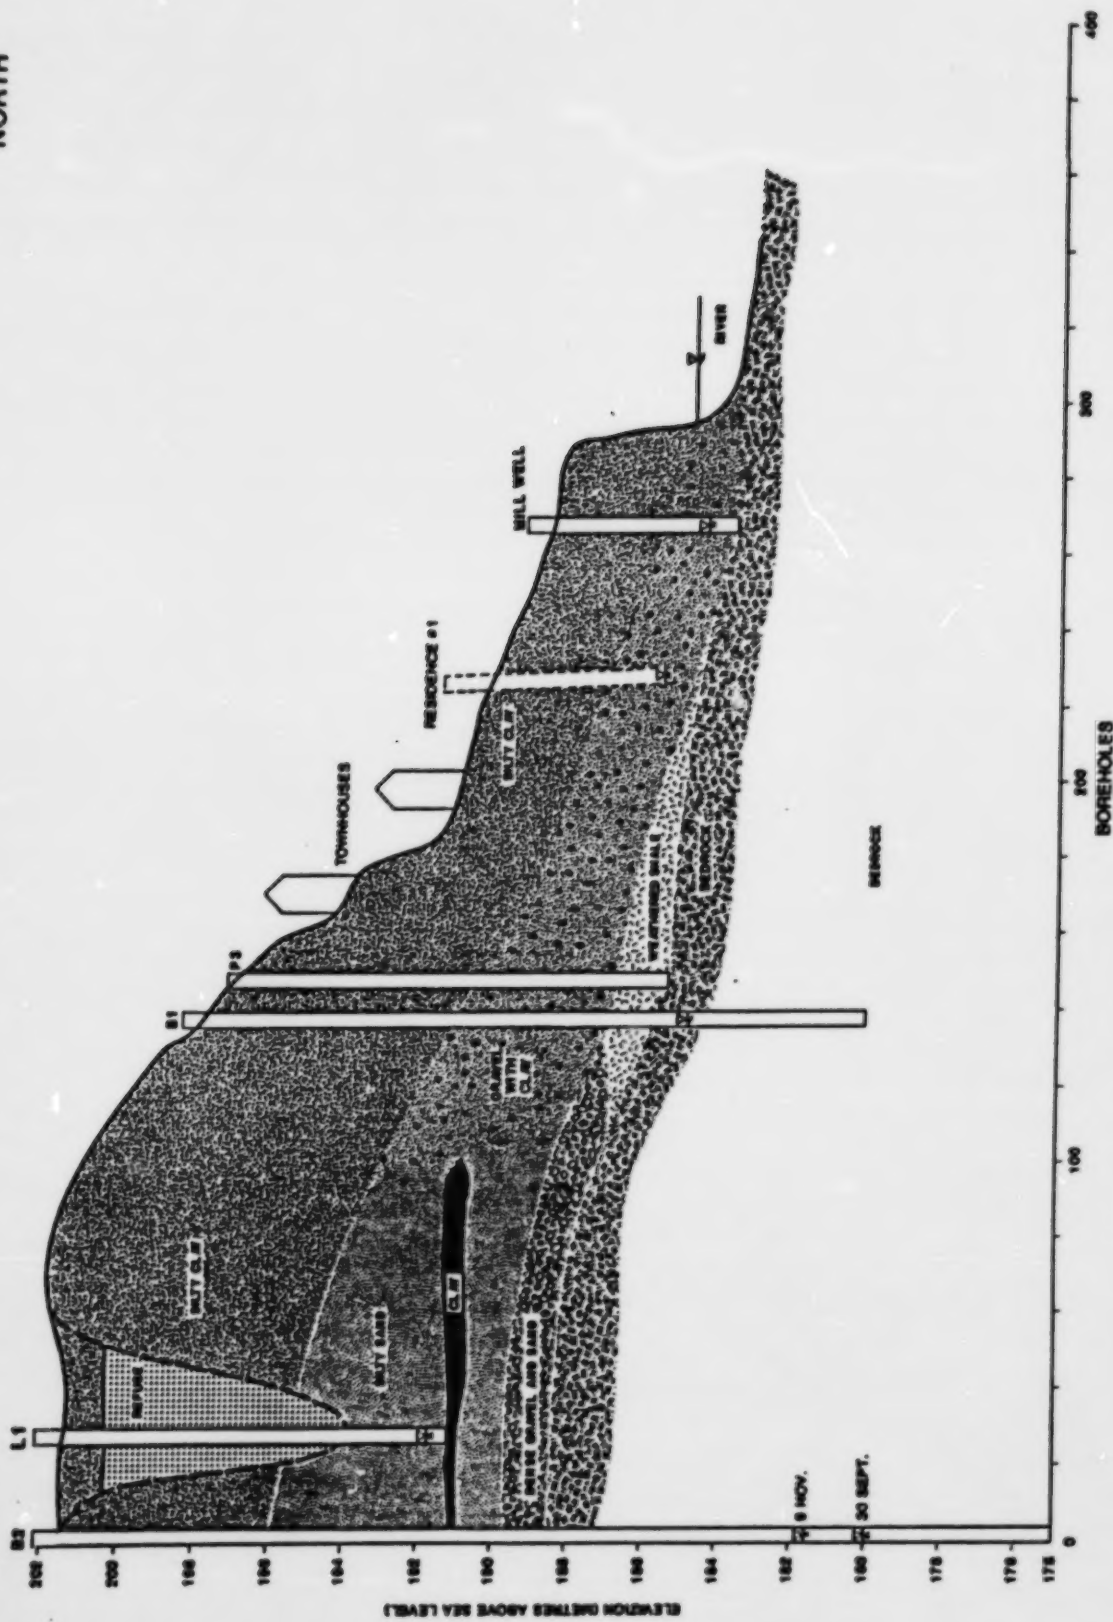
FIGURE 3

Figure 3 is a conceptual geological cross-section through the site, derived from borehole logs, well records, field observation and knowledge of the geological history of the area. Boreholes are shown on the section for the purpose of illustrating ground water elevations only. Because the section is conceptual, the stratigraphic interfaces encountered in the boreholes may not exactly match those illustrated.

In general terms, the stratigraphy in the site vicinity comprises silty clay glaciolacustrine deposits, overlying granular ice contact deposits, which in turn overlie the shale and limestone bedrock.

In the area above the Grand River Valley, where the landfill is located, the glaciolacustrine deposits range from approximately 5 m to 8 m thick. The underlying ice contact deposits range in thickness from about 7.5 m to 4.5 m, thinning towards the river, and comprise predominantly silty sand, with minor amounts of gravel. A thin clay seam (10 cm), with 0.25 m of saturated sand above it, was encountered within the ice contact deposits in borehole L1,

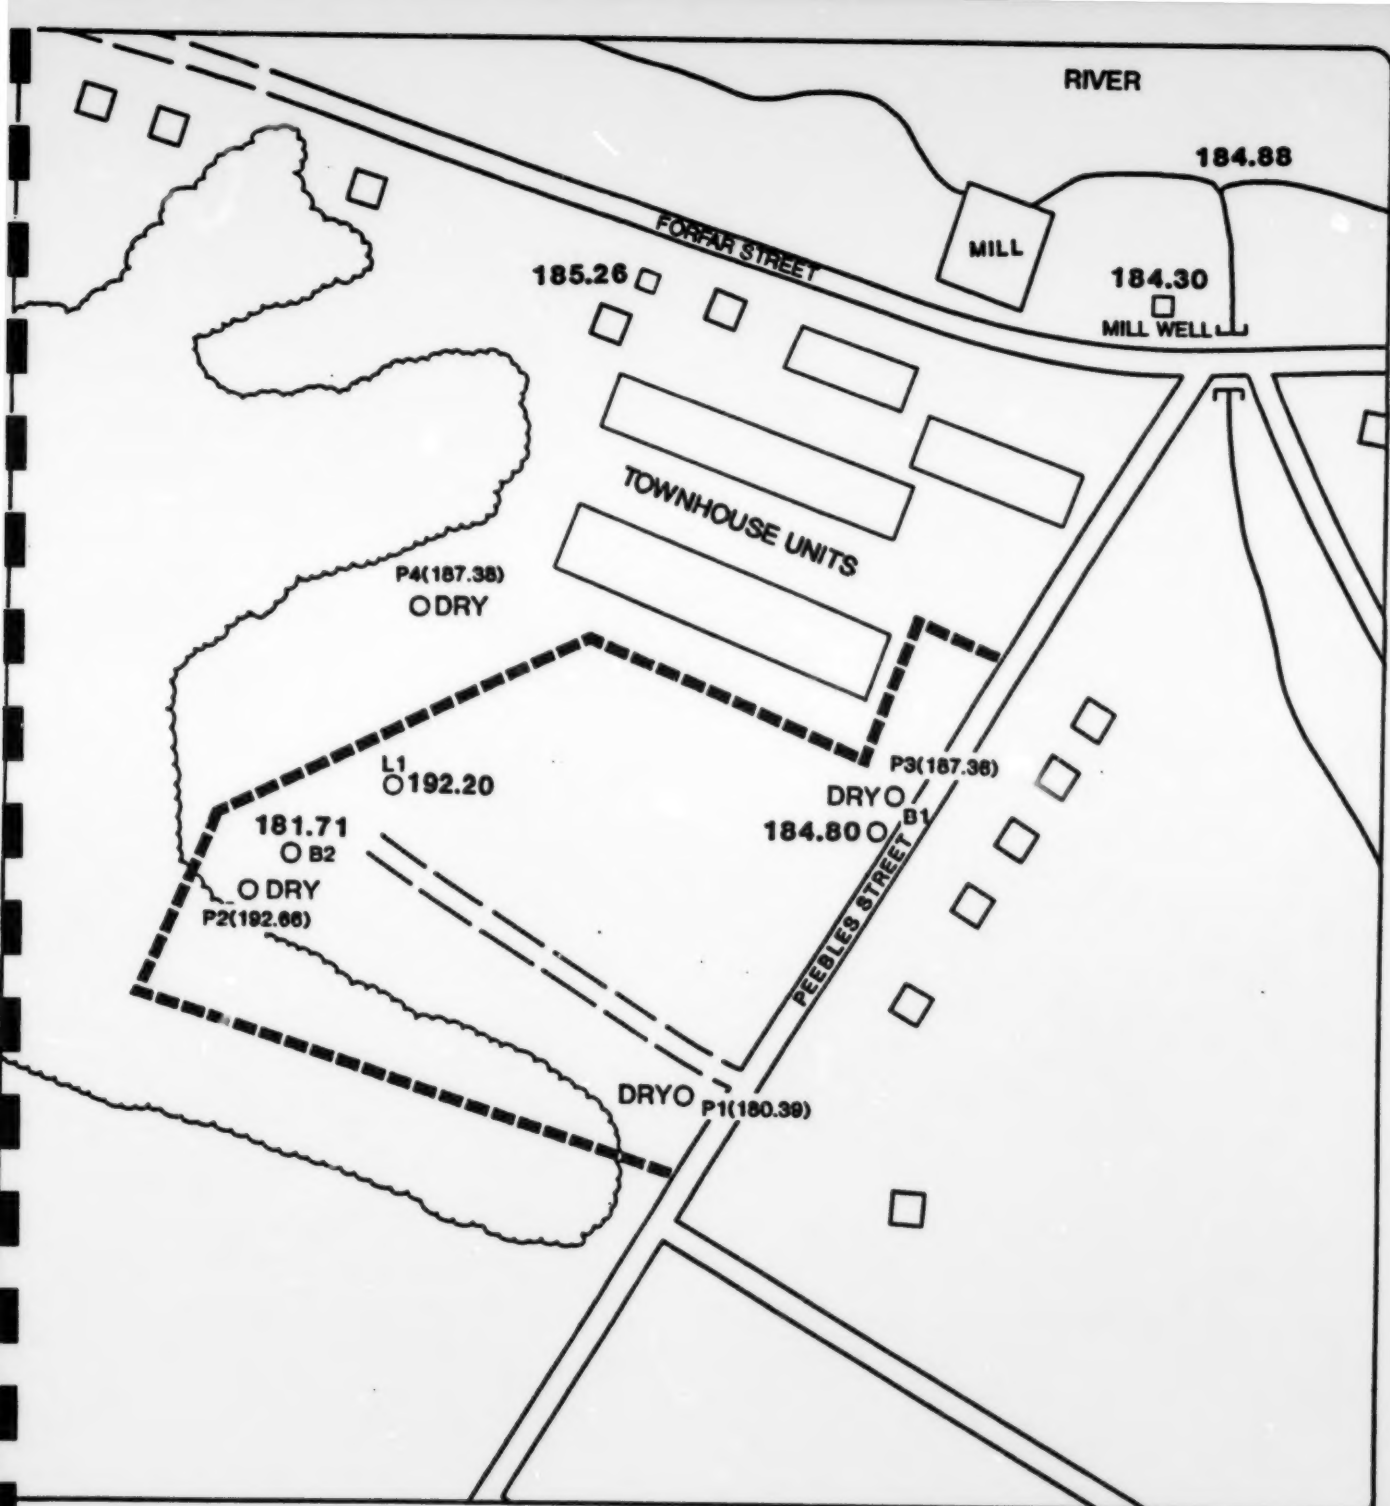
FIGURE 4

Ground water elevations measured in the monitors on-site on several dates are summarized in Table 3. Also shown are ground water elevations measured in two dug wells (Residence 1, Mill Well, Figure 3) and the elevation of the Grand River surface. Borehole logs for the dug wells are not available, however they are likely terminated at, or slightly into the bedrock. Elevations measured on 15 August 1988 are plotted on Figure 4.

All the overburden piezometers on site, with the exception of L1, were consistently dry on six occasions between 28 July and 9 November 1988. In borehole L1, there was consistently less than 1 m of water (elevation 192.14-192.23 m) likely reflecting a perched water table on top of the clay seam found at elevation 191.76 m. This perched ground water likely flows southeasterly along the surface of the clay seam.

Ground water elevations in monitors B1 and B2 show the water table to be within the bedrock, and below the measured river elevation. In borehole B1, water was encountered under pressure at elevation 181.2 m approximately 3 m into the rock. The monitor produced a significant yield, indicating a zone of high permeability, and quickly achieved hydraulic equilibrium at a head of approximately 184.8 m. This elevation is consistent with those measured in the Residence #1 and Mill wells and it is likely that those wells are completed in the same high permeability zone.

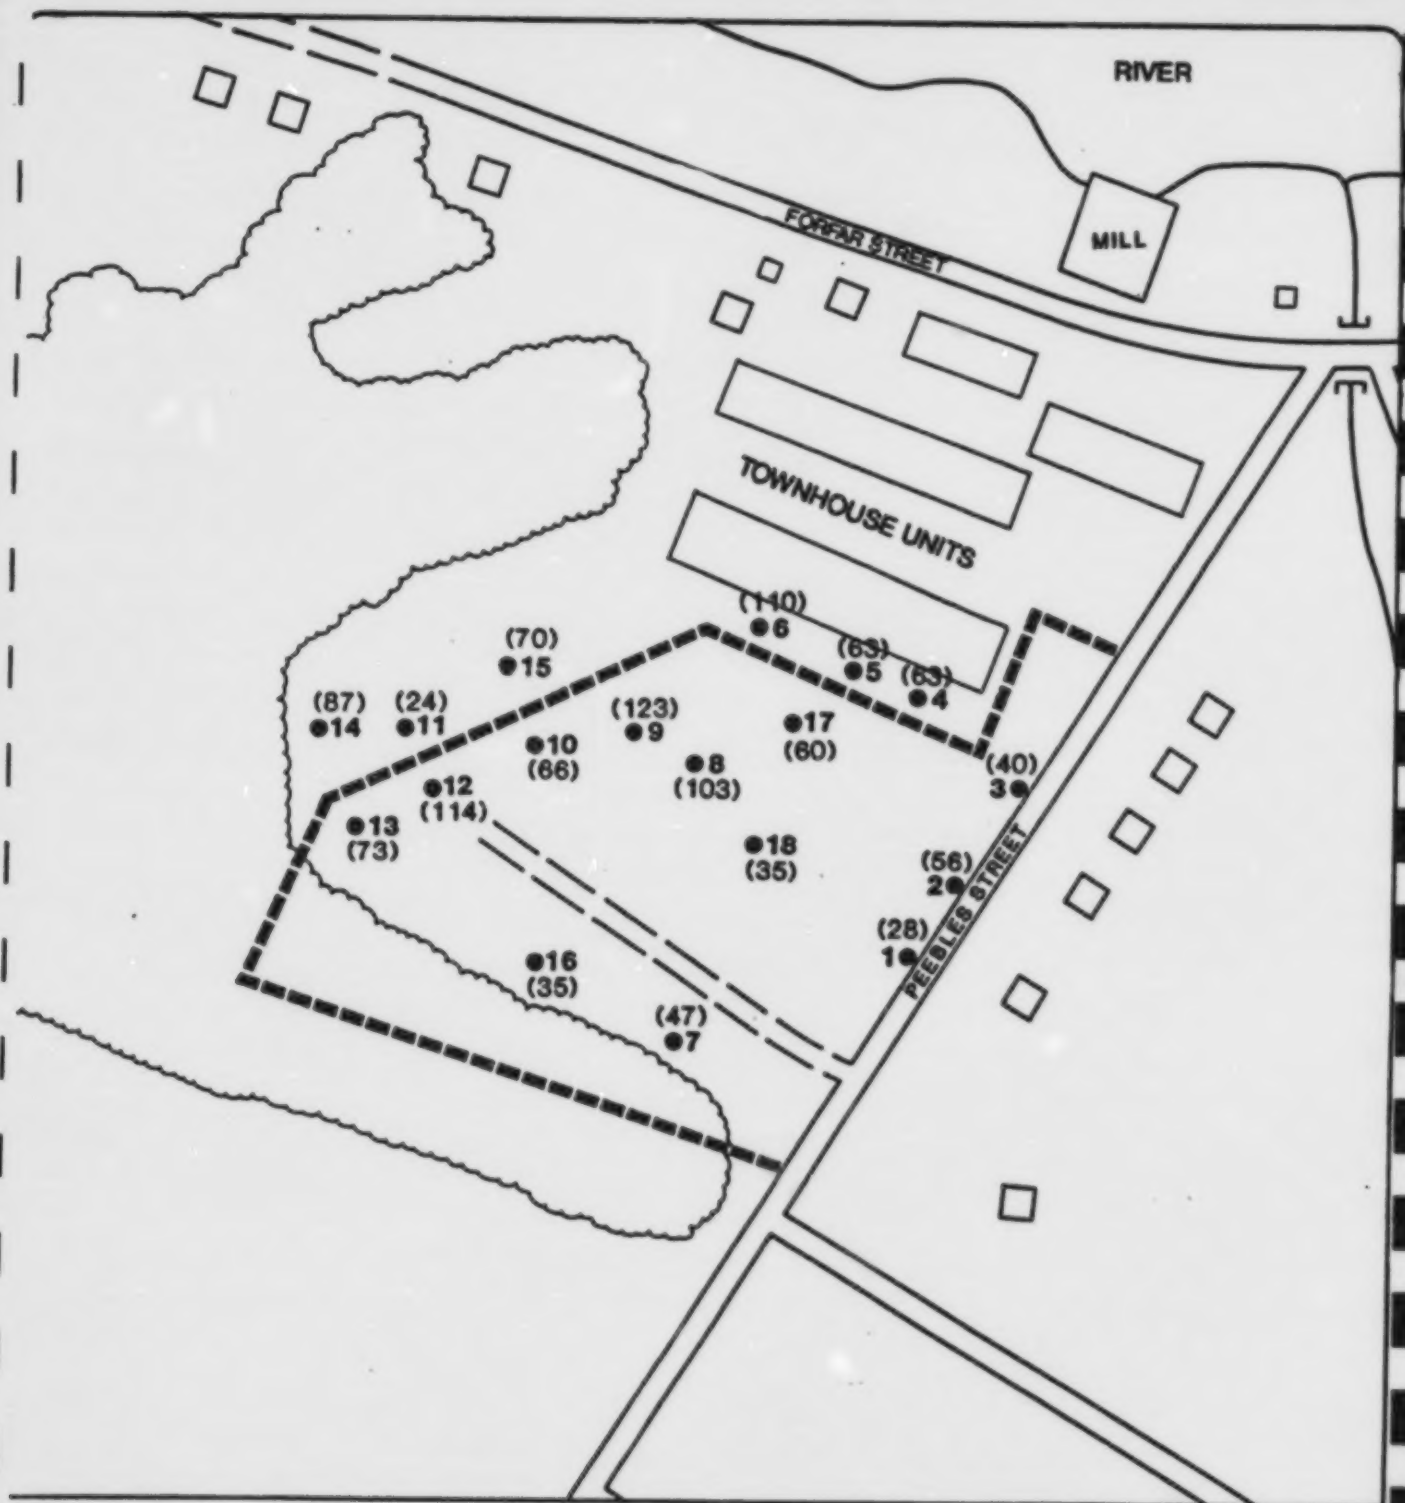
FIGURE 5

The results of the methane gas readings are shown on Table 5 and on Figure 5.

The methane gas readings were found to be less than 123 ppm, (.25% LEL) at all 18 locations tested. There is no indication of significant methane gas production within the operational boundaries of the landfill site and subsequently there is no indication of methane gas migration outside of the landfill site boundaries.
